Water-efficient toilets in older buildings: an investigation of potential drainline issues

A review of the performance of existing low-flow toilet installations and whole-building retrofits within Montreal's social housing stock

April 2015

Prepared for the CMHC by: Sara Finley, GGB Associates / Écohabitation 5555 ave de Gaspé, suite 200 Montréal QC H2T 2A3 (514)803-8012 sara@ggbassociates.ca

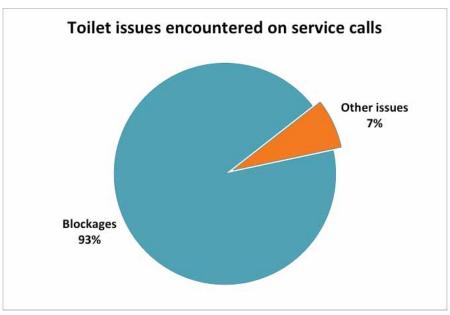
Figure 1

During the period of study, the OMHM plumbing department responded to a total of 97 service calls from residents complaining of toilet performance issues. Of those service calls, 90 (93%) were related to blocked toilets or drainlines. These cases are the focus of this study.

Other issues encountered included leaks, cracks, toilets loose on their base, leaking seals, and in one case, scale build-up that was interfering with toilet function. These non-blockage problems are considered outside of the scope of this study as they are primarily related to improper installation, wear and tear, or other factors unrelated to toilet flush volume.

Fig.1	Toilet issues encountered on service calls	6
Fig.2	Cause of toilet blockage: human error vs. technology failure	7
Fig.3	Toilet Prevalence / Reported Blockages	8
Fig.4	Toilet vs. drainline blockages	9
Fig.5	Location of blockage incidences by toilet type	10
Fig.6	Toilet prevalence / reported drainline issues	10
Fig.7	6355 Delisle – Whole building water demand	14
Fig.8	3985 Masson – Whole building water demand	14
Fig.9	Survey results	15
List of tak	oles	
Table 1	Study timeline	4
Table 2	OMHM toilet type prevalence	5
Table 3	Summary of results	11

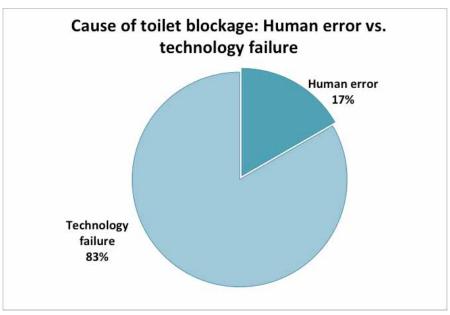
Figure 2

Because this study seeks to examine the relationship between flush volume and drainline performance, blockage issues related to human error (improper use) must be filtered out. Service call reports indicating that the cause of toilet or drainline failure was linked to improper use were separated from the data under analysis in order to isolate only those cases directly related to flush volume. Although human error is always a possible source of toilet failure, no reliable link can be established to relate these cases with toilet flush volume or drainline performance.

Of the 90 service call reports related to toilet blockage, 15 (17%) were attributed to improper use. The reasons for toilet malfunction in all of these cases was flushing of items not intended to be disposed of in the toilet: items found included rags, toothbrushes, electrical wires, knives, and in one case, a melted plastic ashtray and pieces of burnt wood. It is important to note that in three instances 'excessive toilet paper' was identified as the cause of blockage. These cases were included in the study because the researchers consider toilet paper, whatever the amount, to be a condition of 'normal' toilet use.

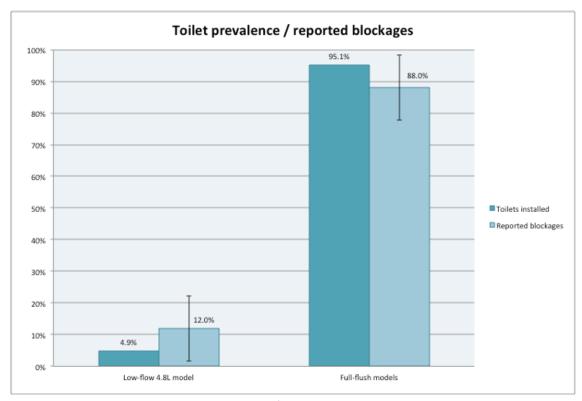
Figure 3

Of the 75 normal-use related blockages reported during the monitoring period, 9 (12%) were encountered in the low-flow 4.8L toilet models. The remaining 66 (88%) were observed in full-flush models. In both cases, the toilet prevalence rates (percentage of each type of toilet installed in OMHM units) are within the sampling error range of the observed rate of blockage. In other words, each type of toilet generated reports of blockage at a rate comparable to its respective prevalence within the OMHM social housing stock. It must be noted that the small sample size of reported incidents (0.4% of the total number of toilets owned by the OMHM) led to a wide margin of error for this small study (10.6% with a confidence interval of 95%).

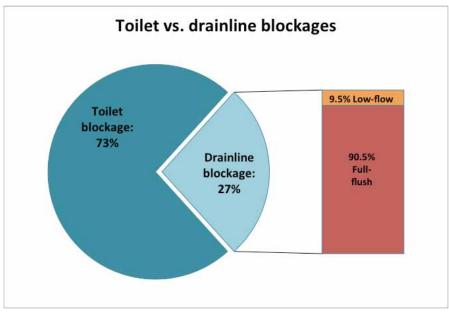
Figure 4

In order to quantify this risk, OMHM plumbers responding to service calls were asked to identify the location of materials that were causing toilets to block. Their responses were separated into two categories: blockage within the toilet body and drainline blockage. Overall, 27% of blockages were attributed to drainline clogging, while the rest (73%) were clogged toilets. Of the 21 cases where the drainline was identified as the location of the clog, just 2 (9.5%) involved a low-flow toilet, and the rest were full-flush, 12/13L models.

Of all the cases of blockage reported during the study period, 22% of low-flow incidents and 27% of full-flush incidents were attributed to drainline clogging. The rest of the reported incidents were cases of clogging within the toilet body, and therefore unrelated to the plumbing configuration, age of construction, or pipe material. Considering the sampling error,

the rate of drainline blockage in low-flow toilets was not observed to be significantly different from that of full-flush models.

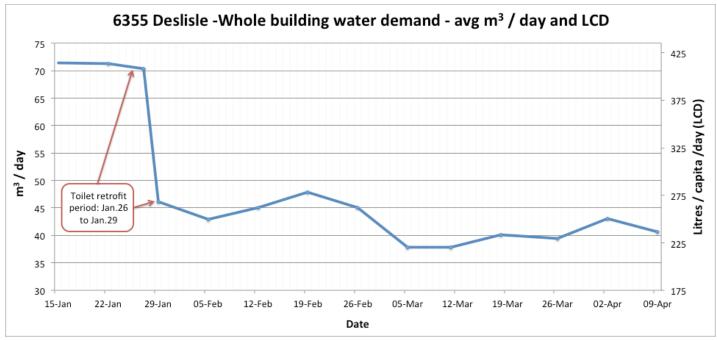
Figure 7

Although Montreal's residential buildings are not metered, the research team thought it would be valuable to benefit from this opportunity to measure the water use of the two study buildings before and after the toilet retrofit. The city of Montreal agreed to donate two meters, and these were installed roughly 2 weeks (in the case of 2355 Delisle) and 3 weeks (in the case of 3985 Masson) before the start of toilet retrofits. The metering results show an impressive decline in overall building and per capita water use before and after the toilet replacement: a 41% reduction in both average daily whole-building water demand and liters/capita/day (LCD) at 2355 Delisle (where 81 of 96 toilets were replaced) and a 17% reduction in both values at 3985 Masson (where 16 of 21 toilets were replaced). The results observed translate to water savings of 168 LCD at the Delisle site and 69 LCD at the Masson site following the toilet replacements. Note that the metering data obtained while toilet replacement work was underway are excluded from these calculations.

See next page for metering results. Meter data was averaged to yield mean values of daily water demand for the period between readings. The graphs below show the evolution of whole-building water demands (left axis) and liters per capita per day (LCD) consumed (right axis) over the 9 weeks that metering data was collected. LCD results are based on an occupancy rate of 1.82 persons/unit at 2355 Delisle, and 1.1 persons/unit at 3985 Masson.

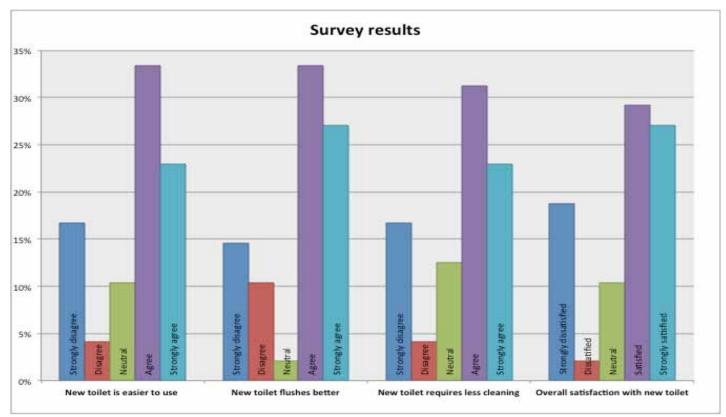
Figure 9

Following the 4-month study period, surveys were distributed to all the residential units in both buildings where toilets had been replaced. The survey asked respondents to mark one of five boxes (strongly disagree / disagree / neutral / agree / strongly agree) for each of the following three statements:

- 1. The new toilet is easier to use than the old toilet
- 2. The new toilet flushes better than the old toilet
- 3. The new toilet requires less cleaning than the old toilet And finally,
 - 4. Declare their overall satisfaction with the new toilet (strongly dissatisfied / dissatisfied / neutral / satisfied / strongly satisfied):

The response rate for the survey in the two buildings was 49%. Five surveys had to be removed from the sample because they failed to check only one box per question, and one other was removed because the respondent indicated that their toilet had not been changed. Overall, the surveys displayed a high degree of general satisfaction with the new toilets installed, with the two positive categories (strongly agree/strongly satisfied and agree/satisfied) together garnering between 54-60% of responses to each question, and the two negative categories (strongly disagree/strongly disagree/dissatisfied) totalling 21-25%.
